UH-1 BALLISTIC AND BIRD IMPACT TEST STUDY

## UH-1 BALLISTIC AND BIRD IMPACT TEST STUDY

Goodyear Aerospace Corporation

Final Report

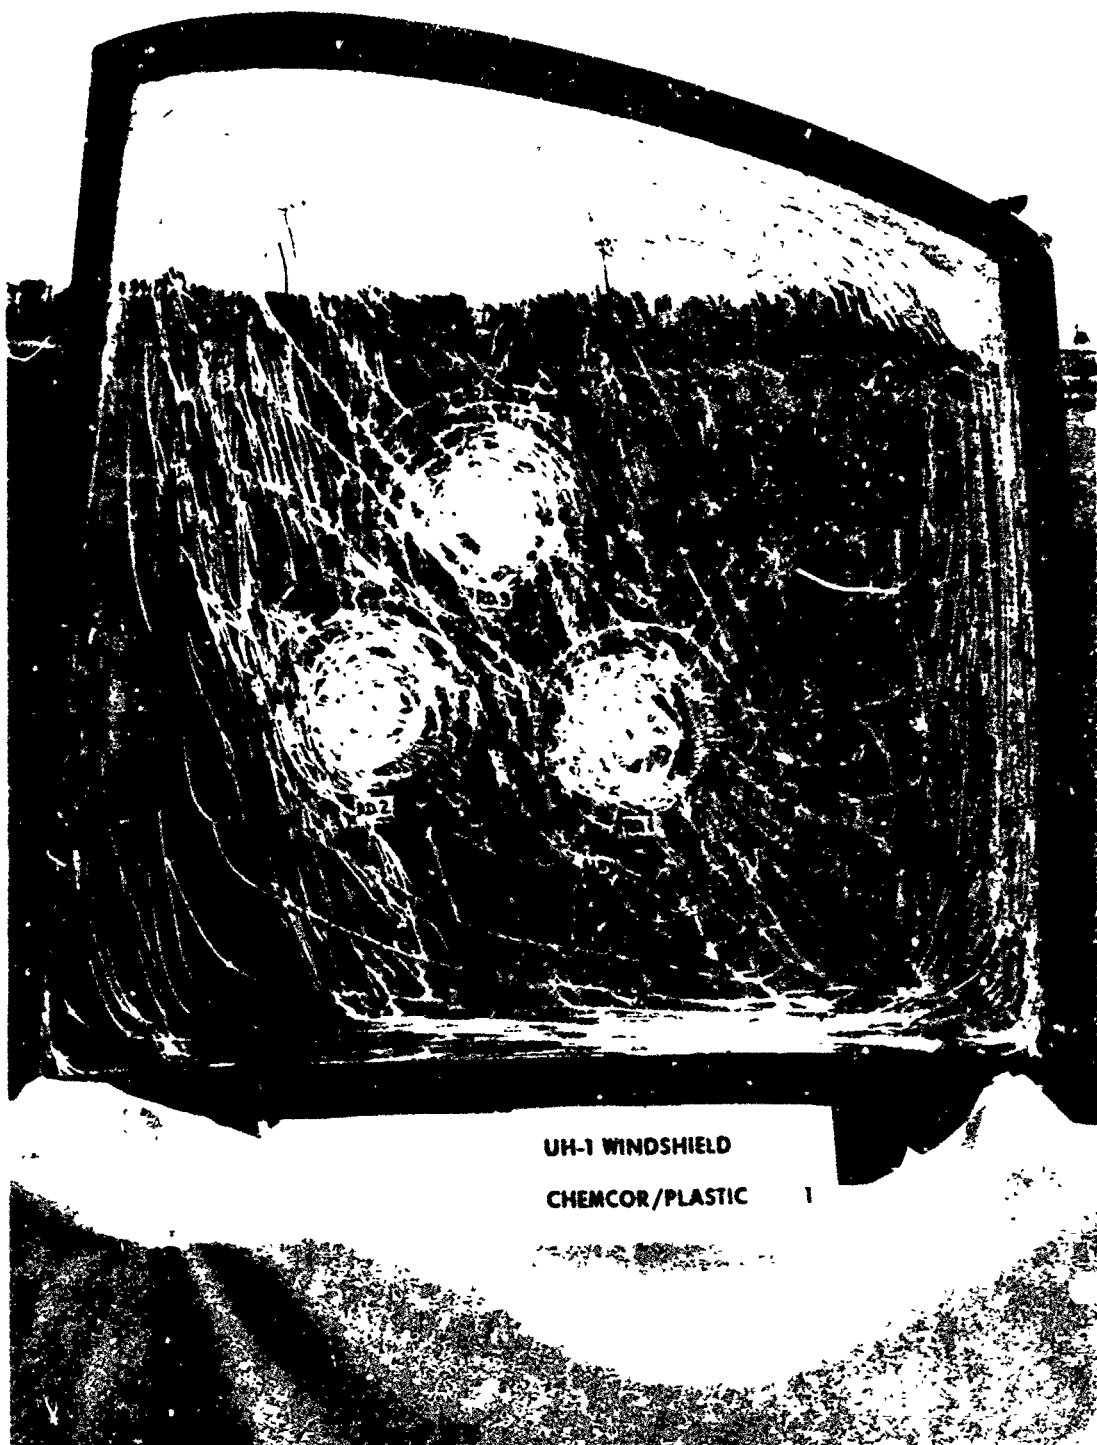
The ballistic penetration of this windshield generated many spall particles, a number of which had potentially lethal penetrating characteristics. These penetrating particles are probably both glass and bullet fragments.

Figure 7 - UH-1 Chemcor-Plastic Windshield, Ballistic Test Article,  
Post-Test Display

This is followed by a cloud of slower, extremely fine particles consisting mostly of glass. The post-hit structural integrity and vision qualities of the windshield appear adequate.

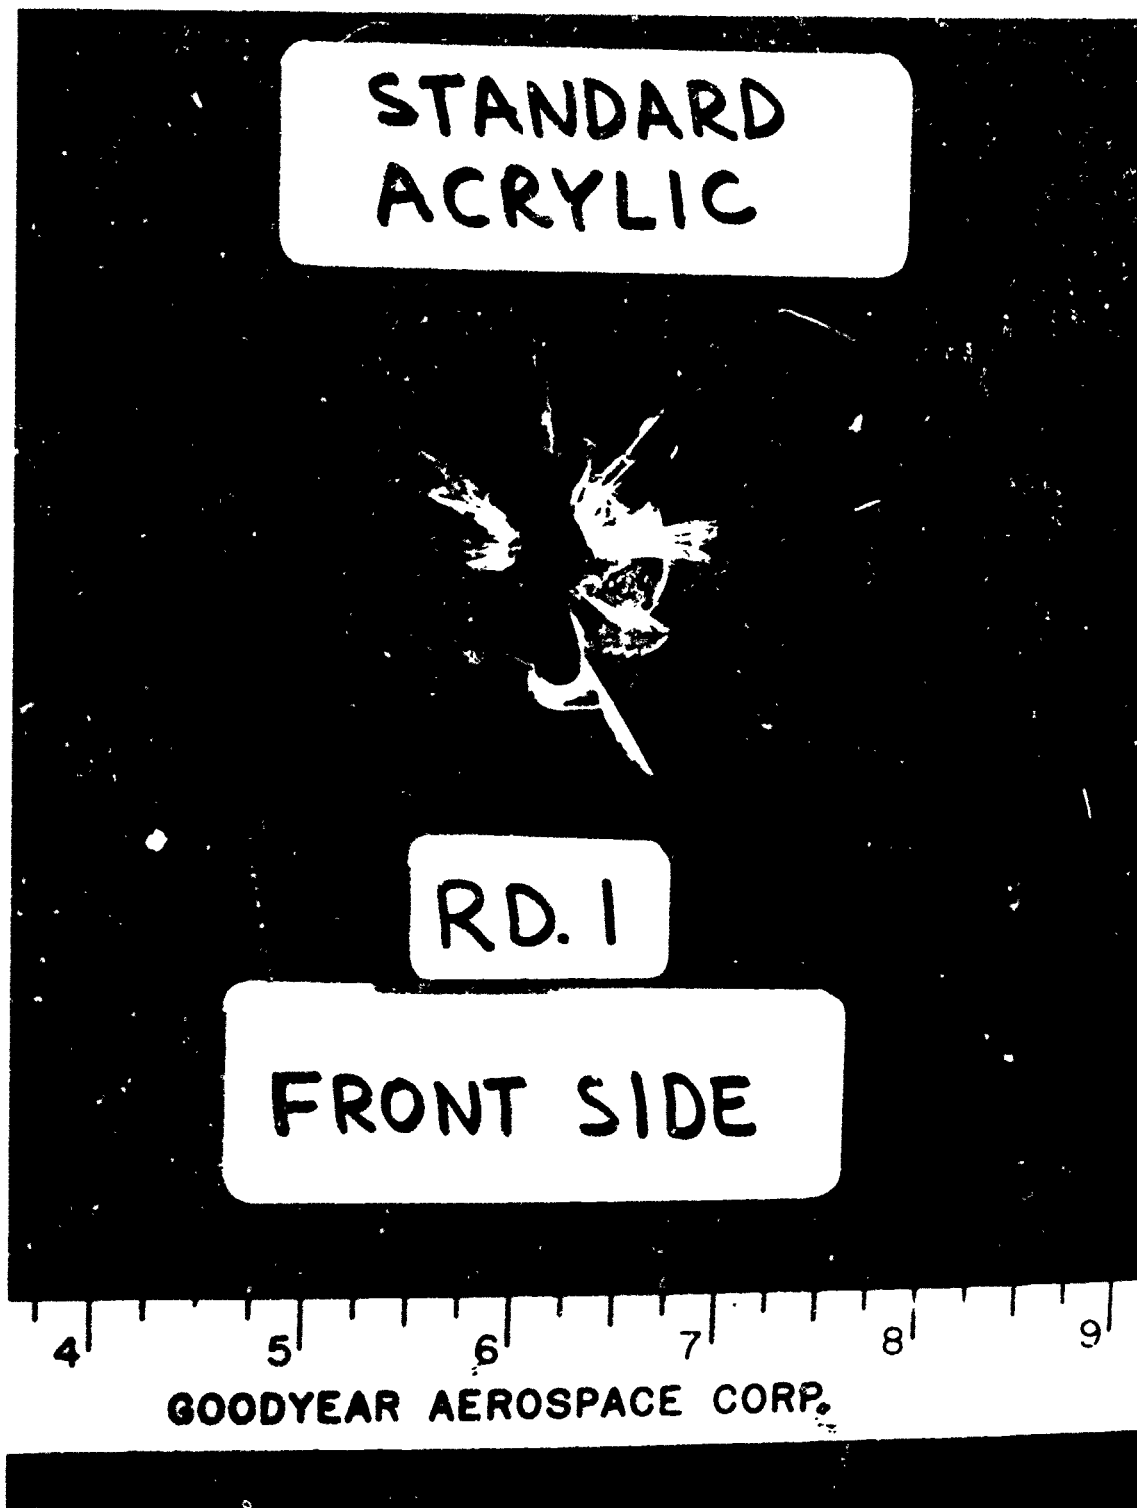
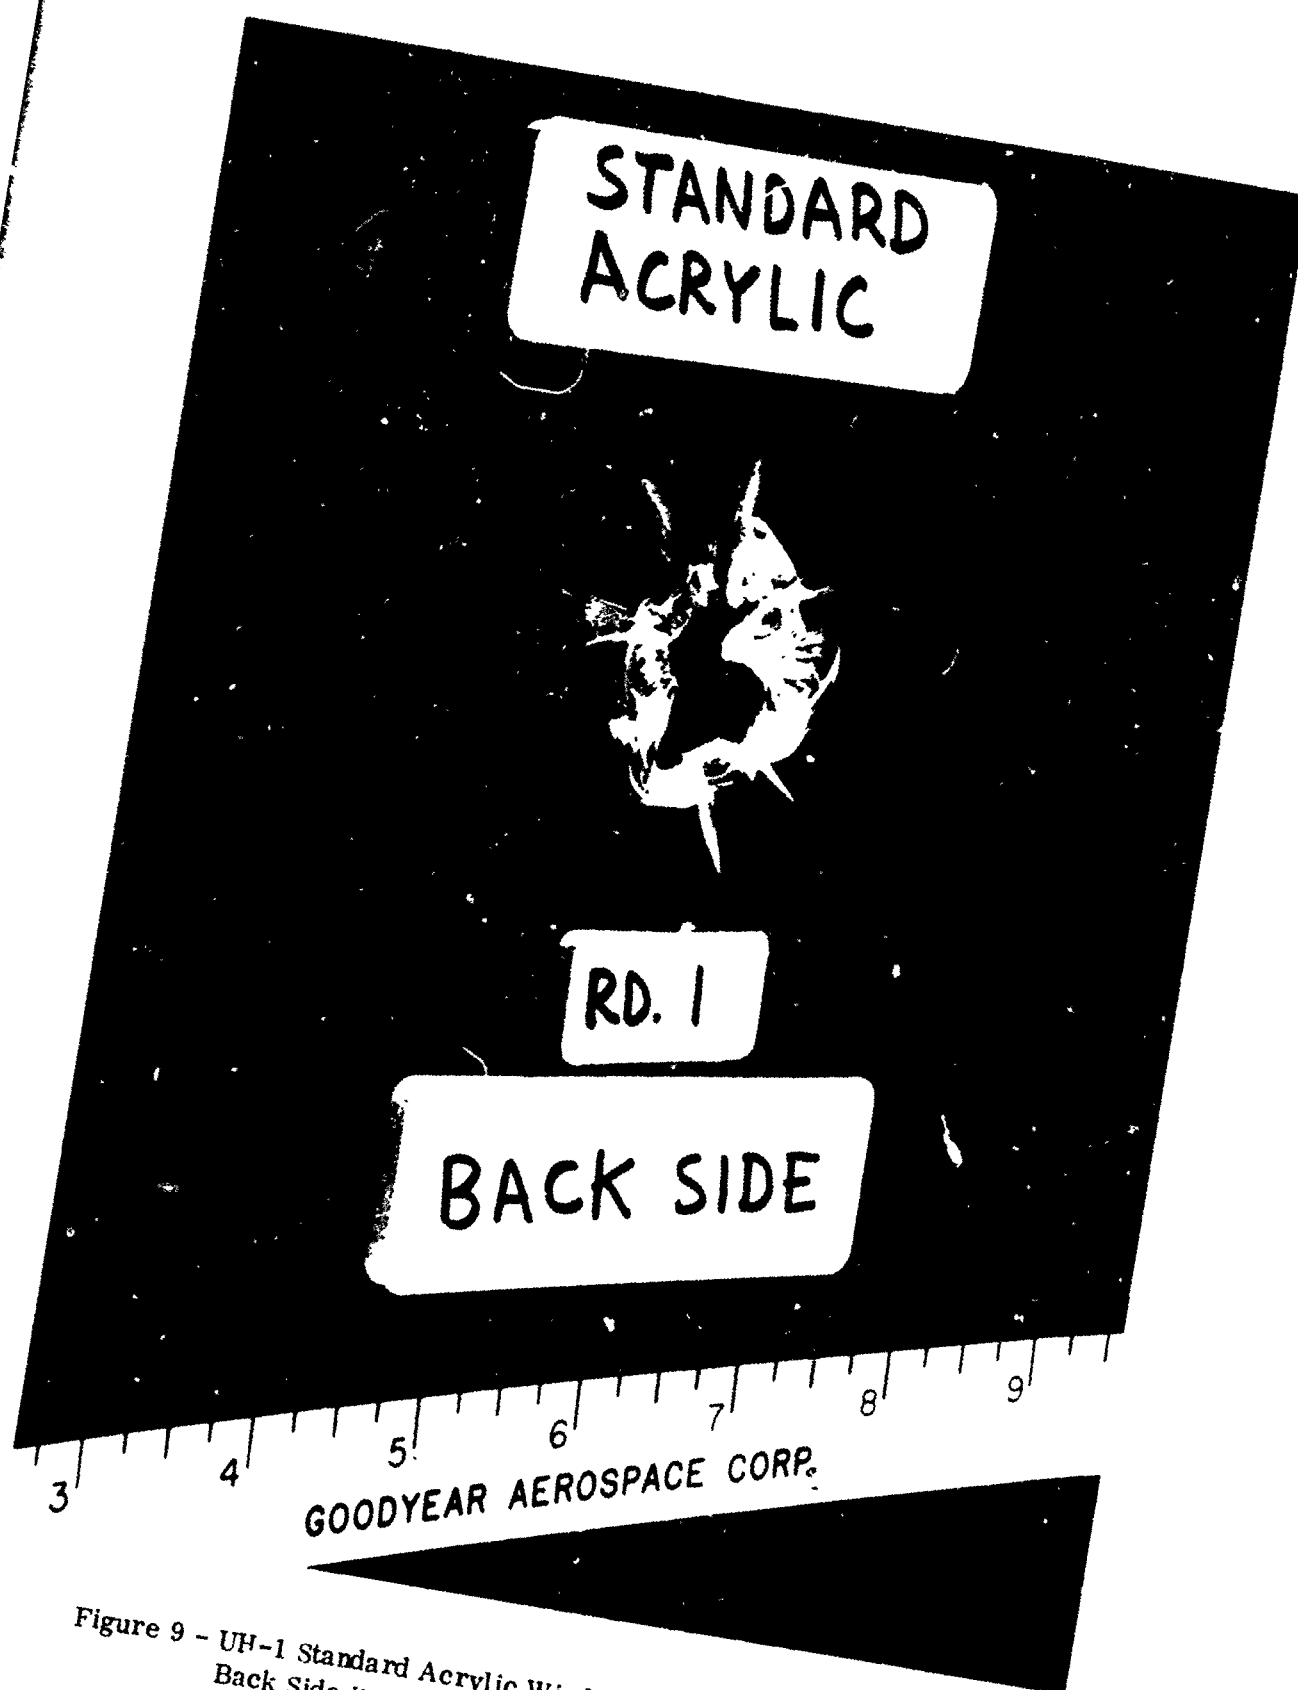
Figure 8 - UH-1 Standard Acrylic Windshield Ballistic Penetration,  
Front Side Detail

Figure 9 - UH-1 Standard Acrylic Windshield Ballistic Penetration,  
Back Side Detail

The acrylic windshield fractures locally at the impact site. A wide variety of particle sizes is removed and widely dispersed. The acrylic particles are sharp edged and potentially dangerous. The extreme dispersion of the particles caused some of them to miss the witness sheet. None of the particles which struck the witness sheet resulted in a potentially lethal perforation.

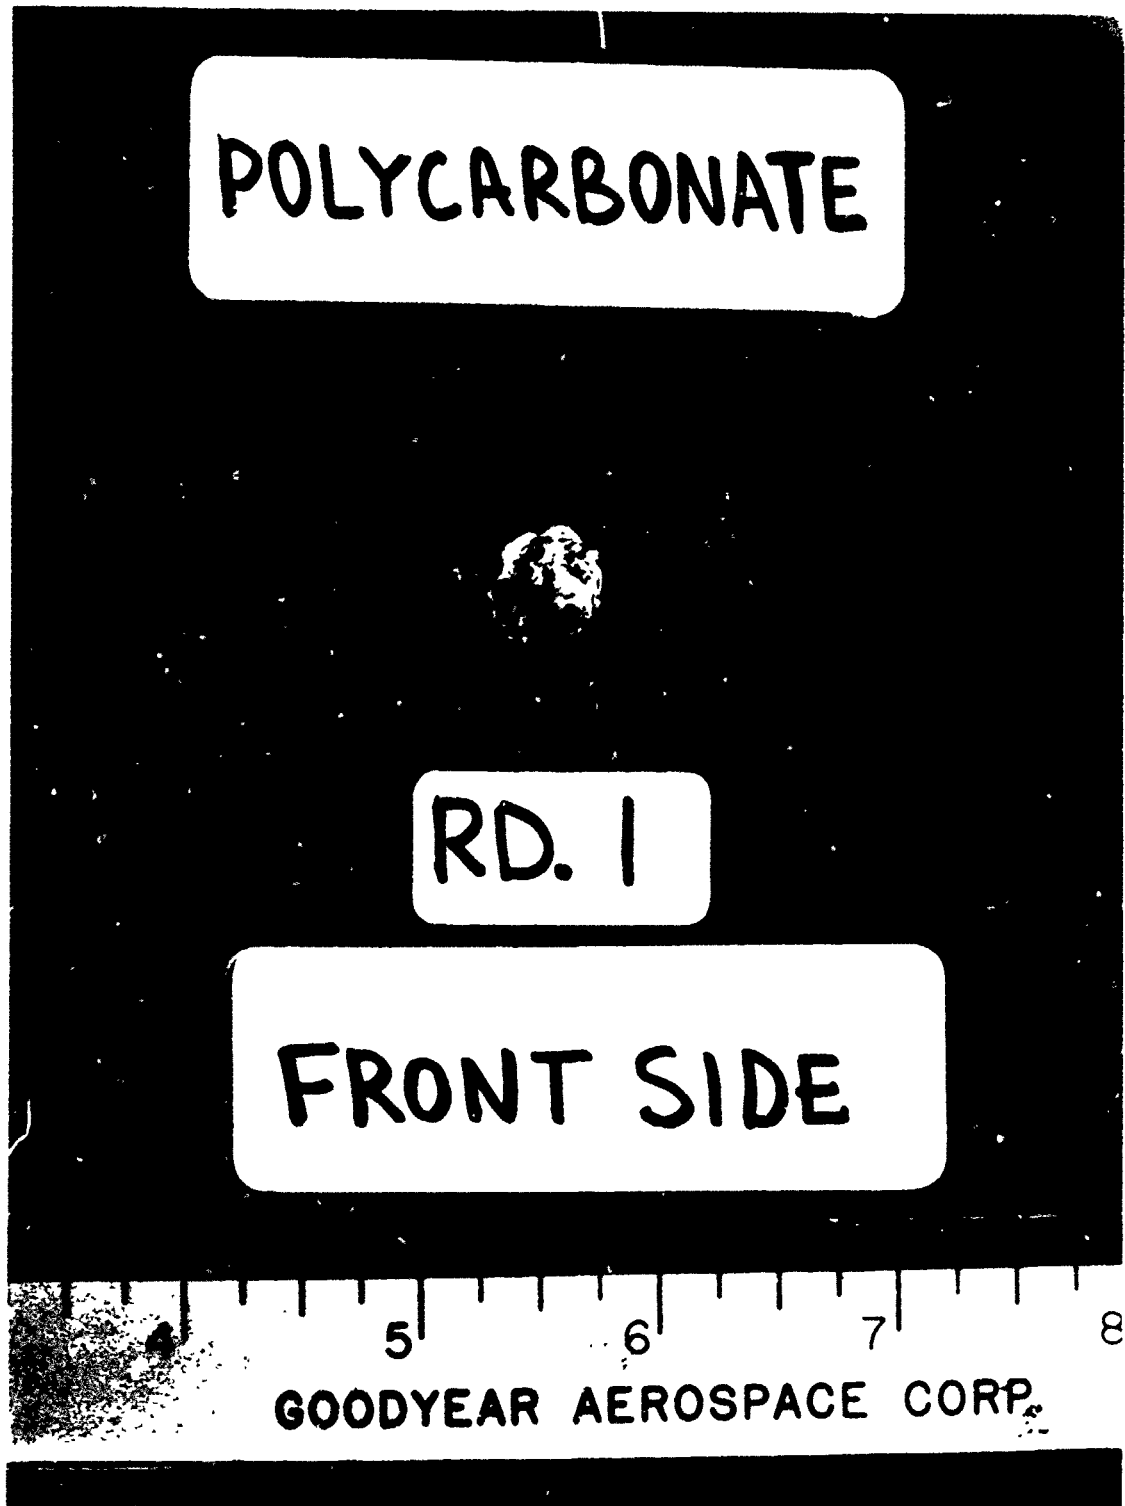
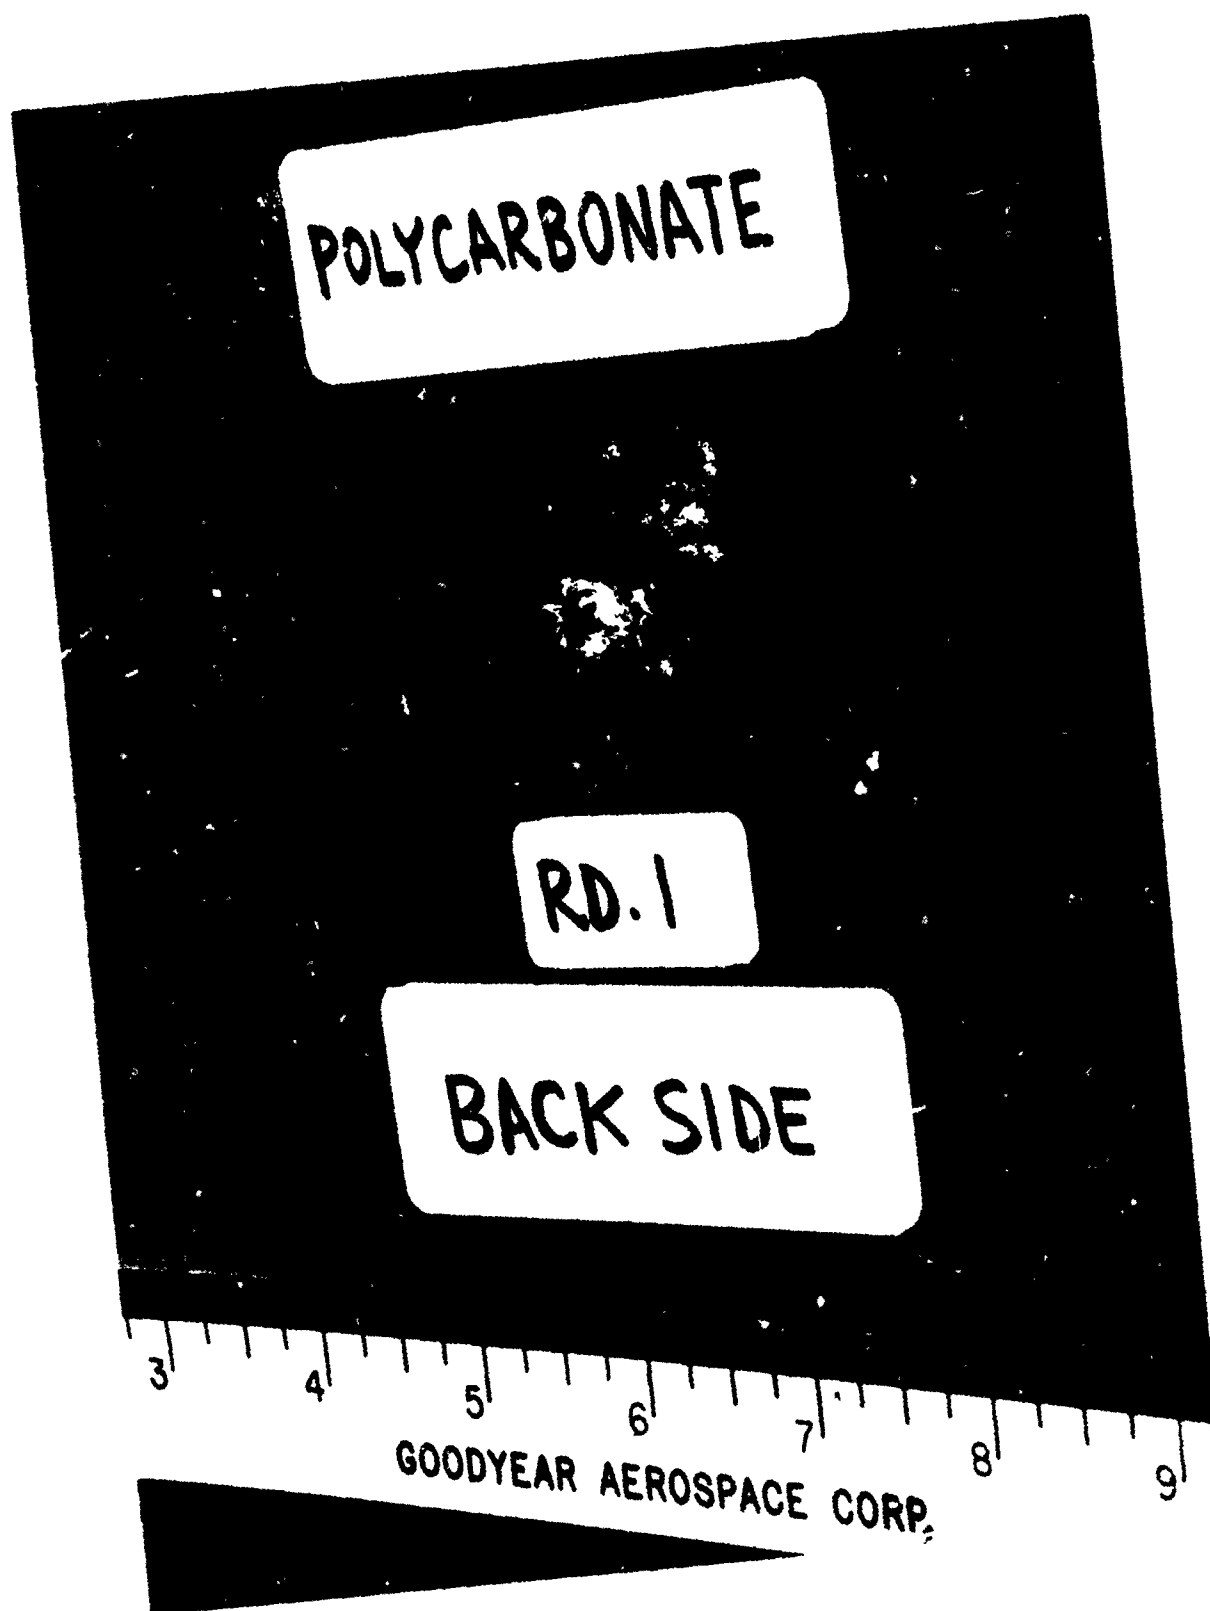
Figure 10 - UH-1 Polycarbonate Windshield Ballistic Penetration,  
Front Side Detail

Figure 11 - UH-1 Polycarbonate Windshield Ballistic Penetration,  
Back Side Detail

Ductile penetration without cracking, and wound closure to approximately a 1/8-inch-diameter hole were typical.

The back side spalling was limited to a very few small polycarbonate particles. None of these particles marked the witness sheets.

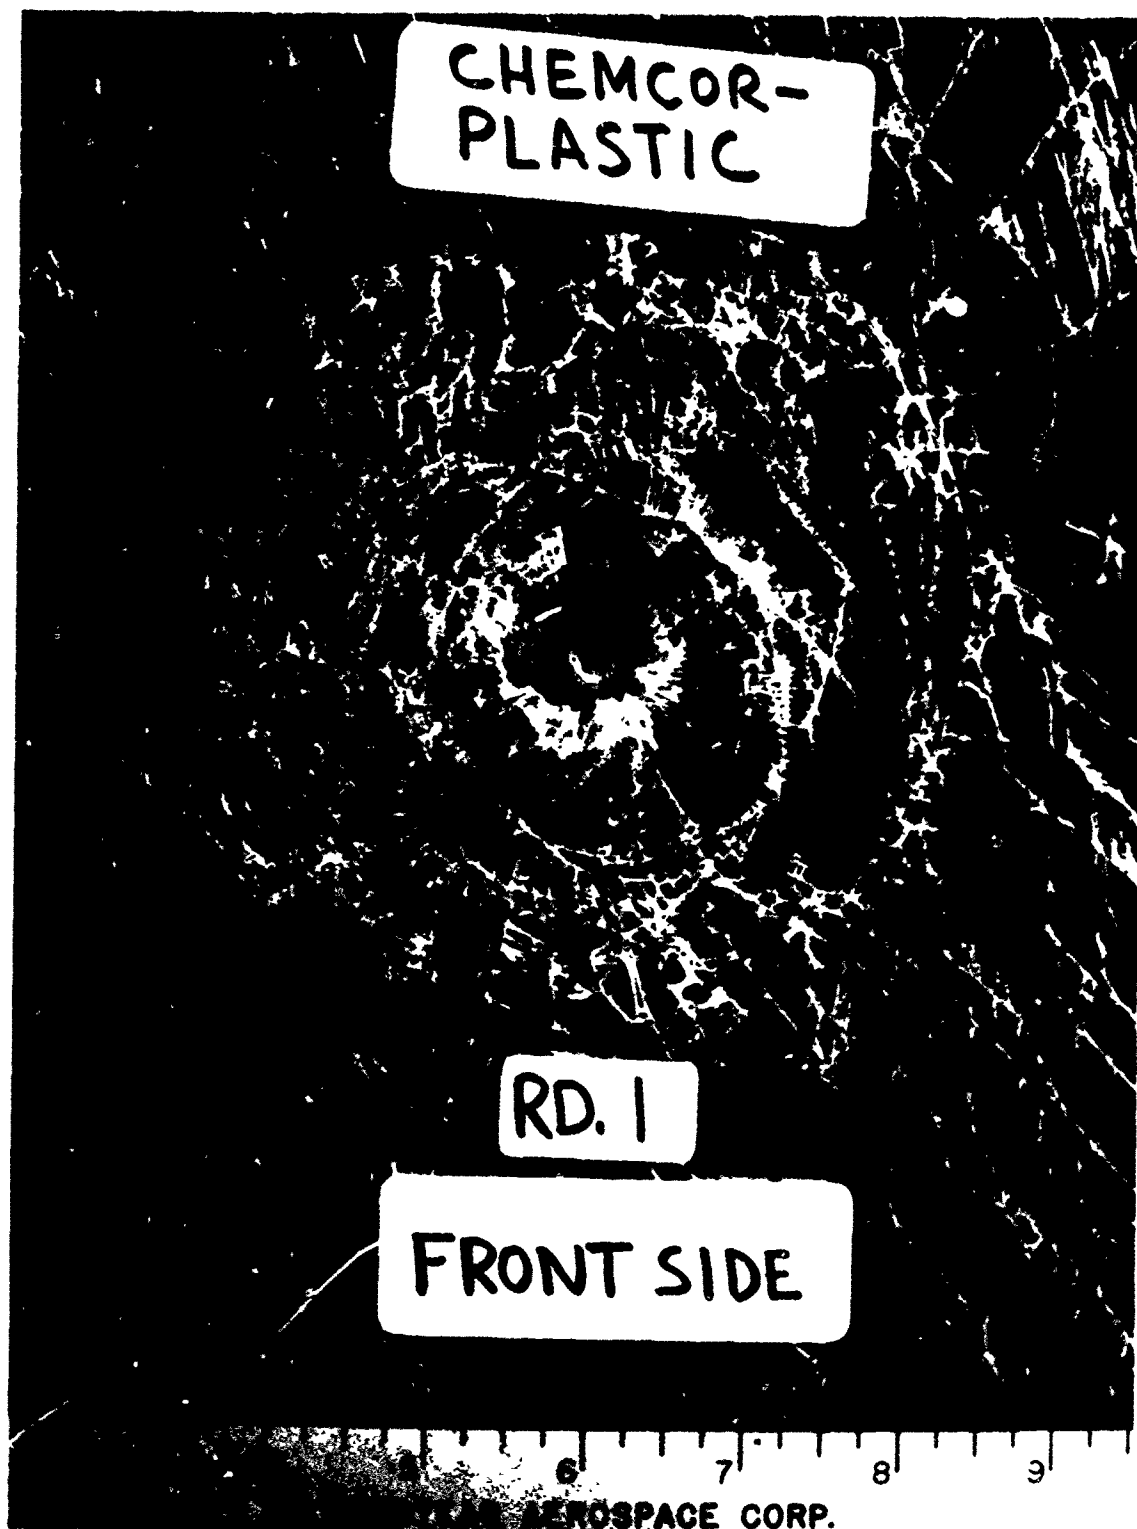
Figure 12 - UH-1 Chemcor-Plastic Windshield Ballistic Penetration,  
Front Side Detail

Figure 13 - UH-1 Chemcor-Plastic Windshield Ballistic Penetration,  
Back Side Detail

The glass outer layer acts to partially break up the projectile. The glass particles and bullet fragments, both having relatively high density, comprise the most hazardous spall. The ductility of the plastic backing ply restricts the dispersion of the spall. The higher-density glass and bullet spall strike the witness sheet at nearly the same instant as the bullet.

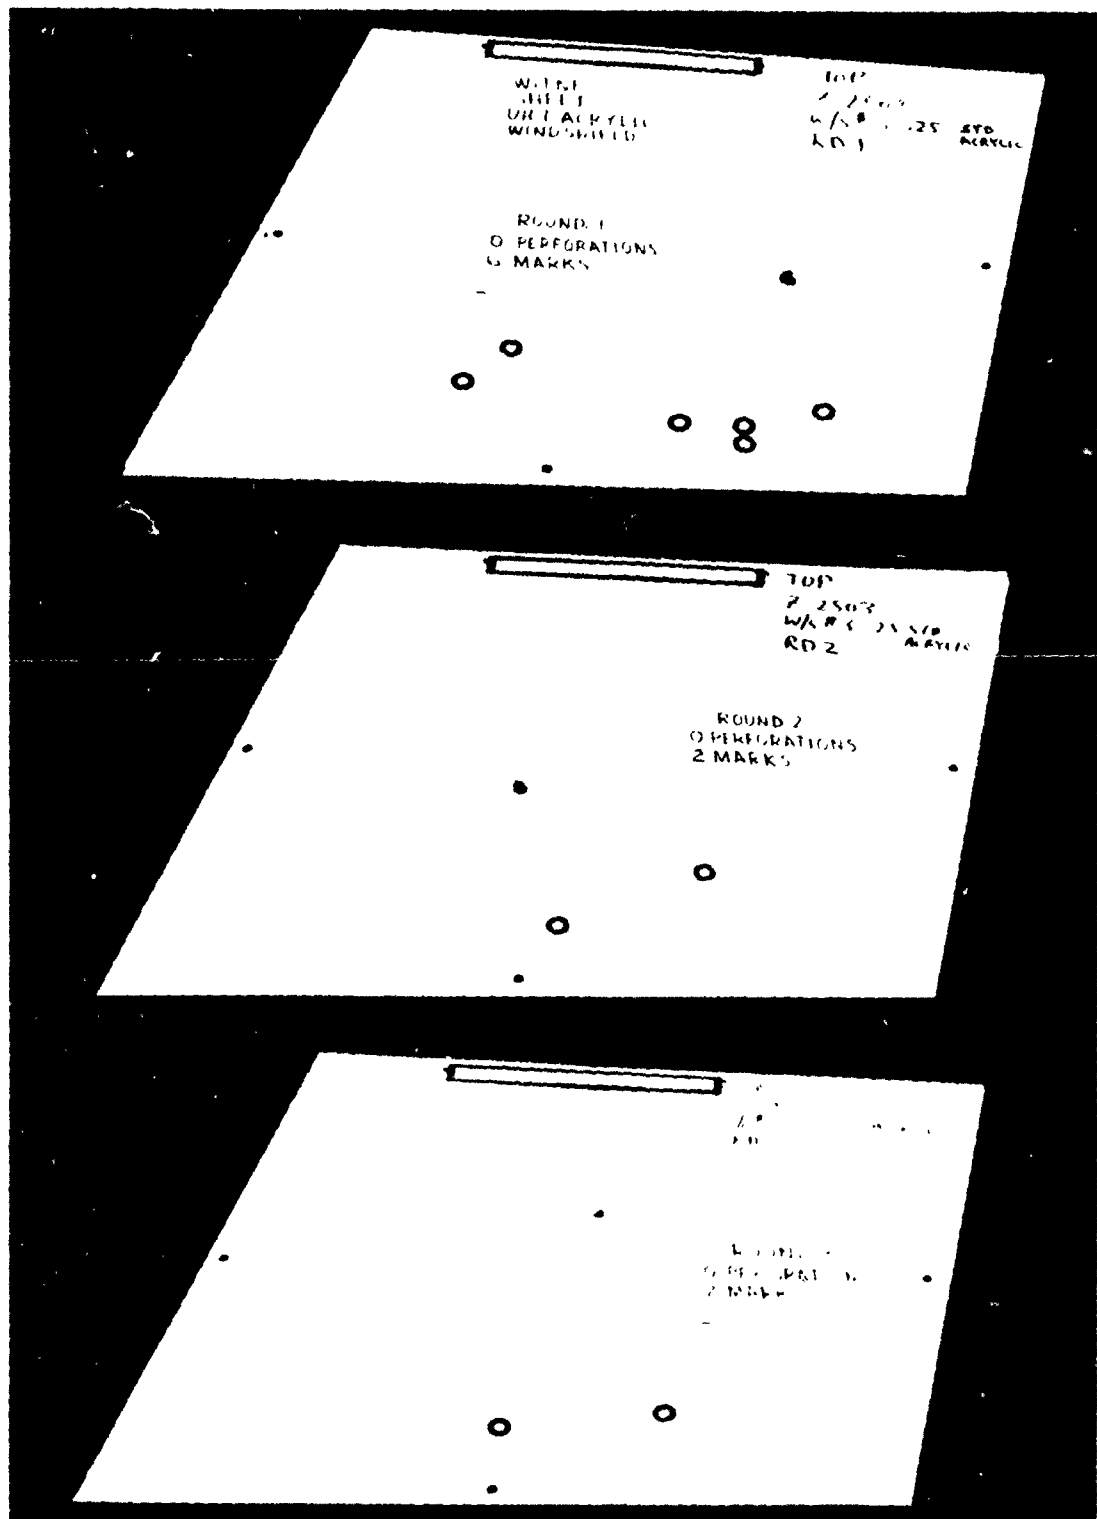
Figure 14 - UH-1 Standard Acrylic Windshield Ballistic Spall Witness Sheets, Post-Test Display

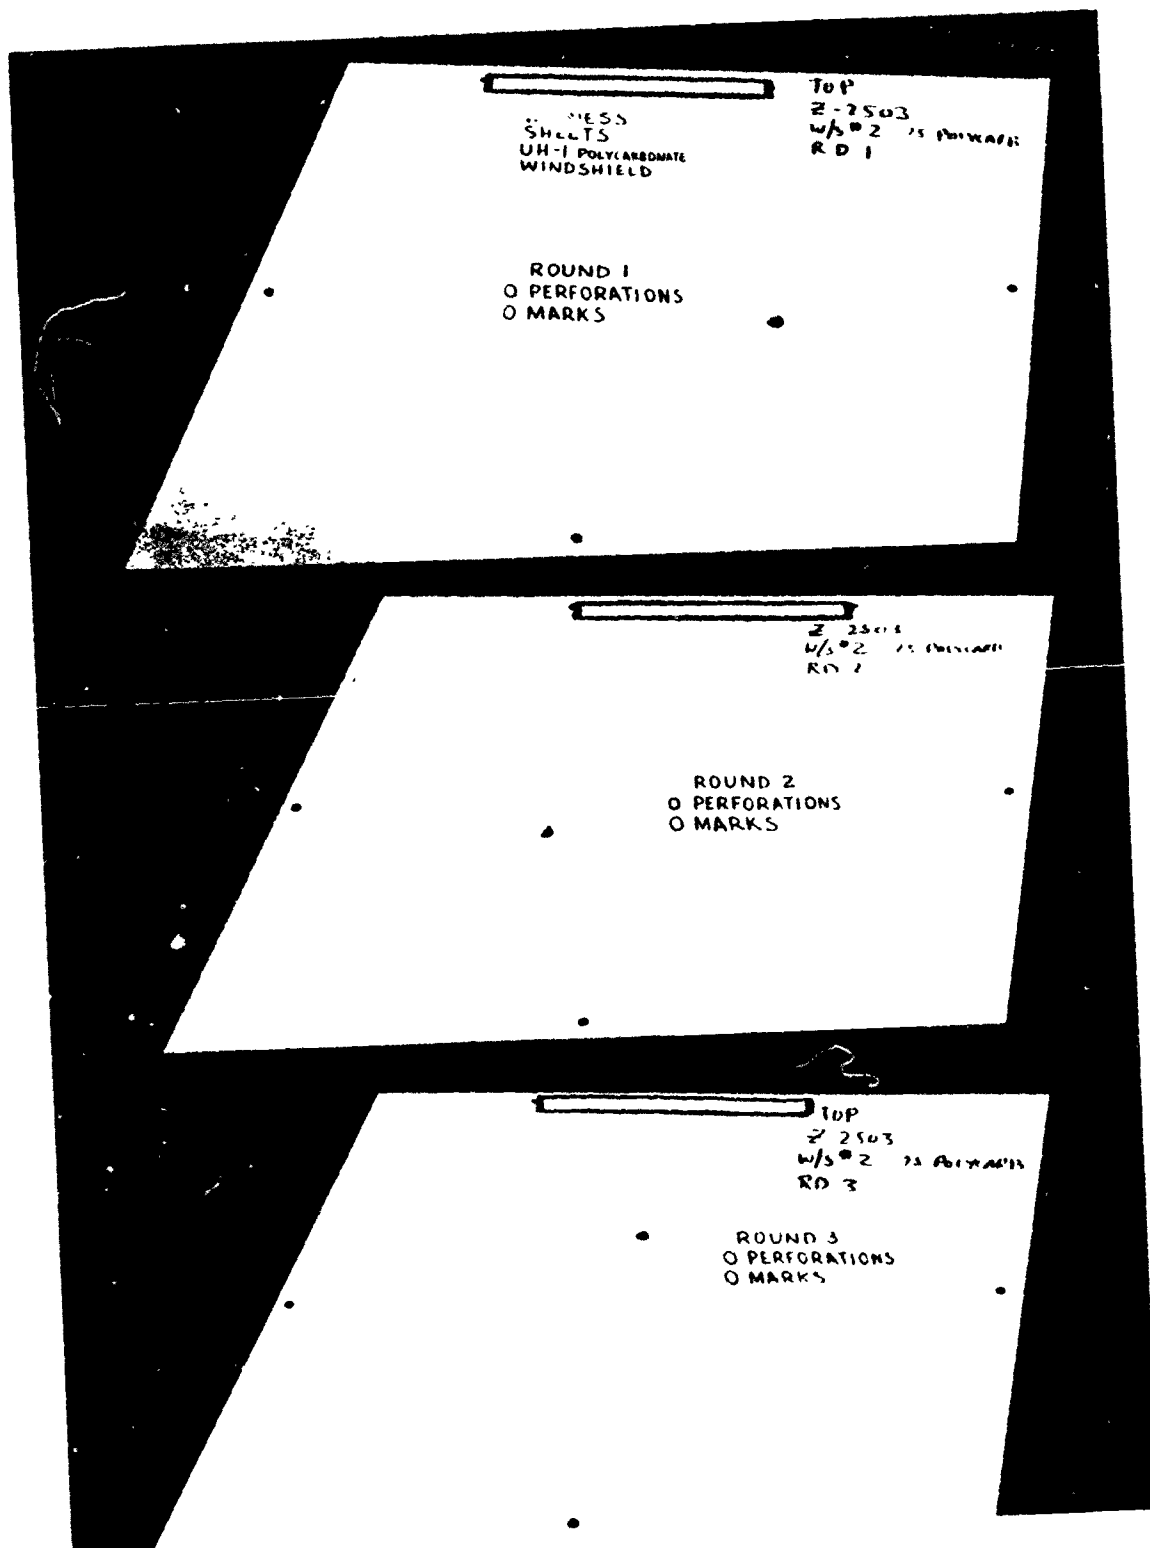
Figure 15 - UH-1 Polycarbonate Windshield Ballistic Spall Witness Sheets,  
Post-Test Display

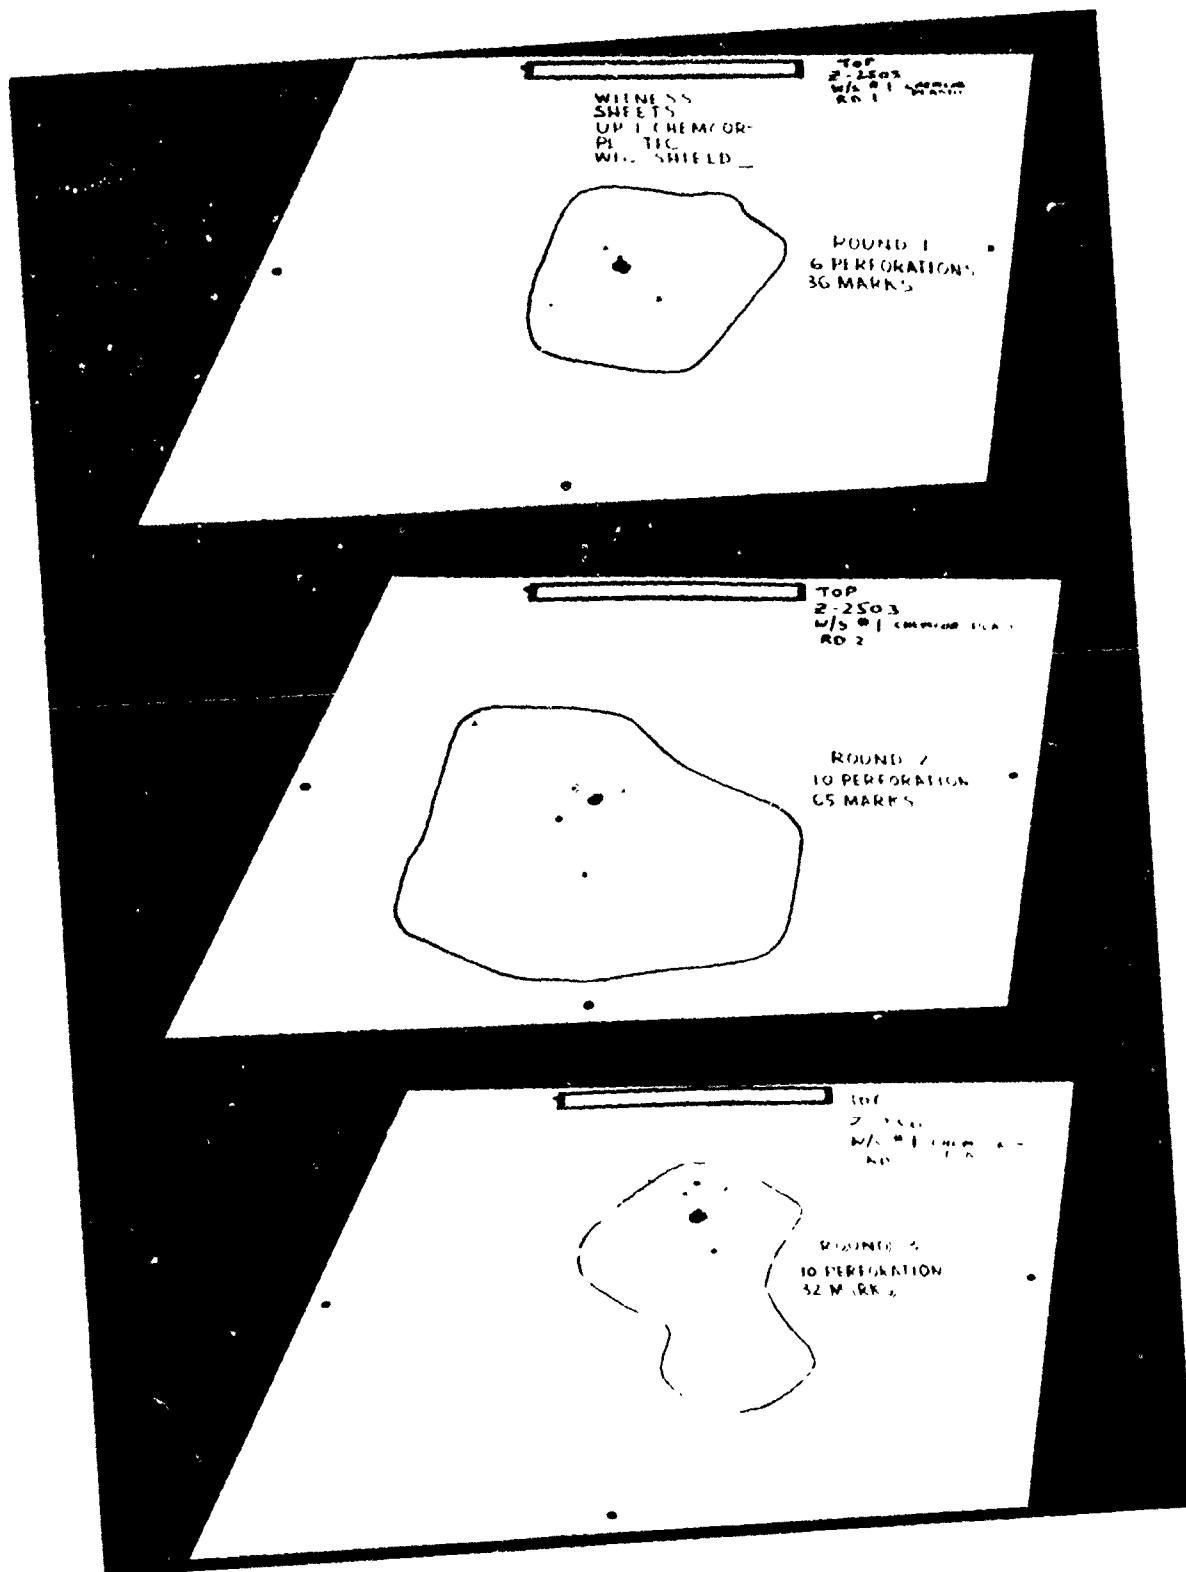
Figure 16 - UH-1 Chem/or-Plastic Windshield Ballistic Spall Witness Sheets, Post-Test Display

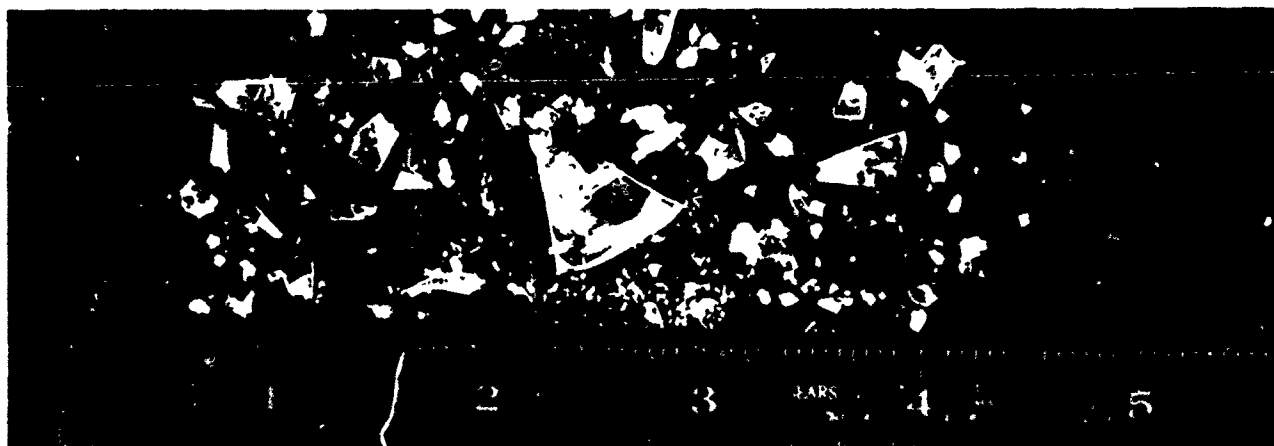
Typical back side spall particles collected following one ballistic penetration of each type of windshield are illustrated in Figure 17. The particles from the Chemcor-plastic composite which perforated the witness sheet were not collected and therefore are not included in Figure 17.

Figure 17 - Typical Ballistic Spall Particles, Single Penetration

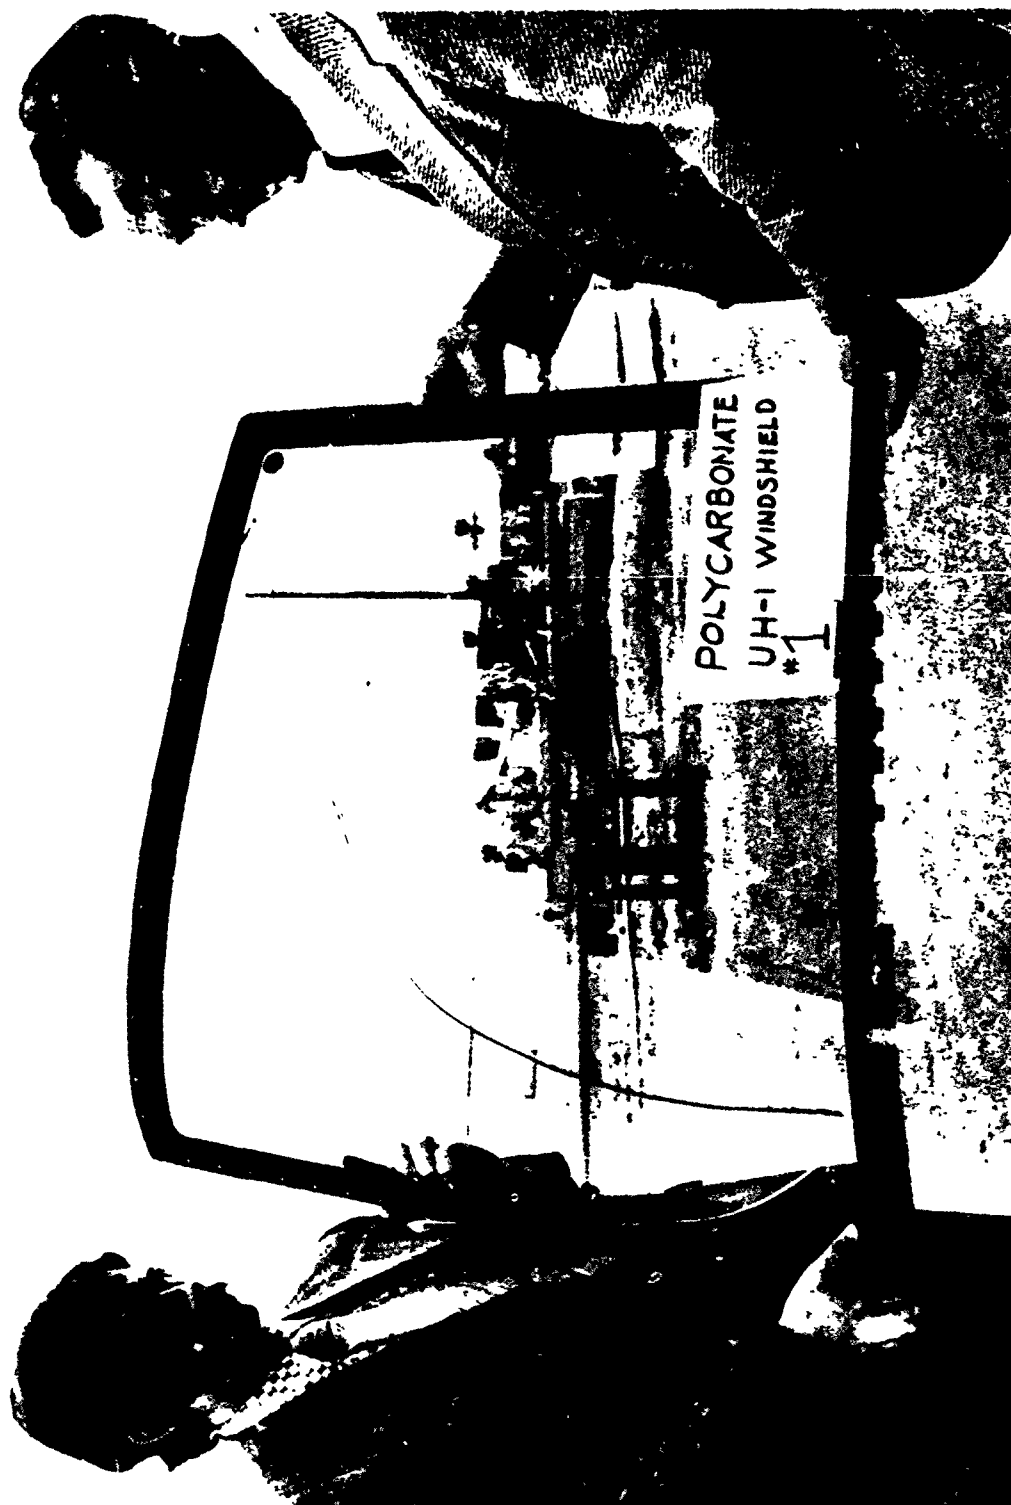
Windshield no. 1 was impacted at 114.5 knots with a four-pound bird. This impact resulted in a diagonal crack running from the upper right-hand corner to the lower left-hand edge of the windshield when viewed from the front (see Figure 20). The bird bounced into the air, and there was no debris in back of the windshield.

Upon close examination of the part, it was noticed that the aircraft structure had bent directly above the spot where the crack terminated. The movies taken confirm the crack initiated in the center of the windshield. The fuselage was bent out into the proper position and readied for the next test.

Figure 20 - Bird-Impacted UH-1 Polycarbonate Windshield Number 1

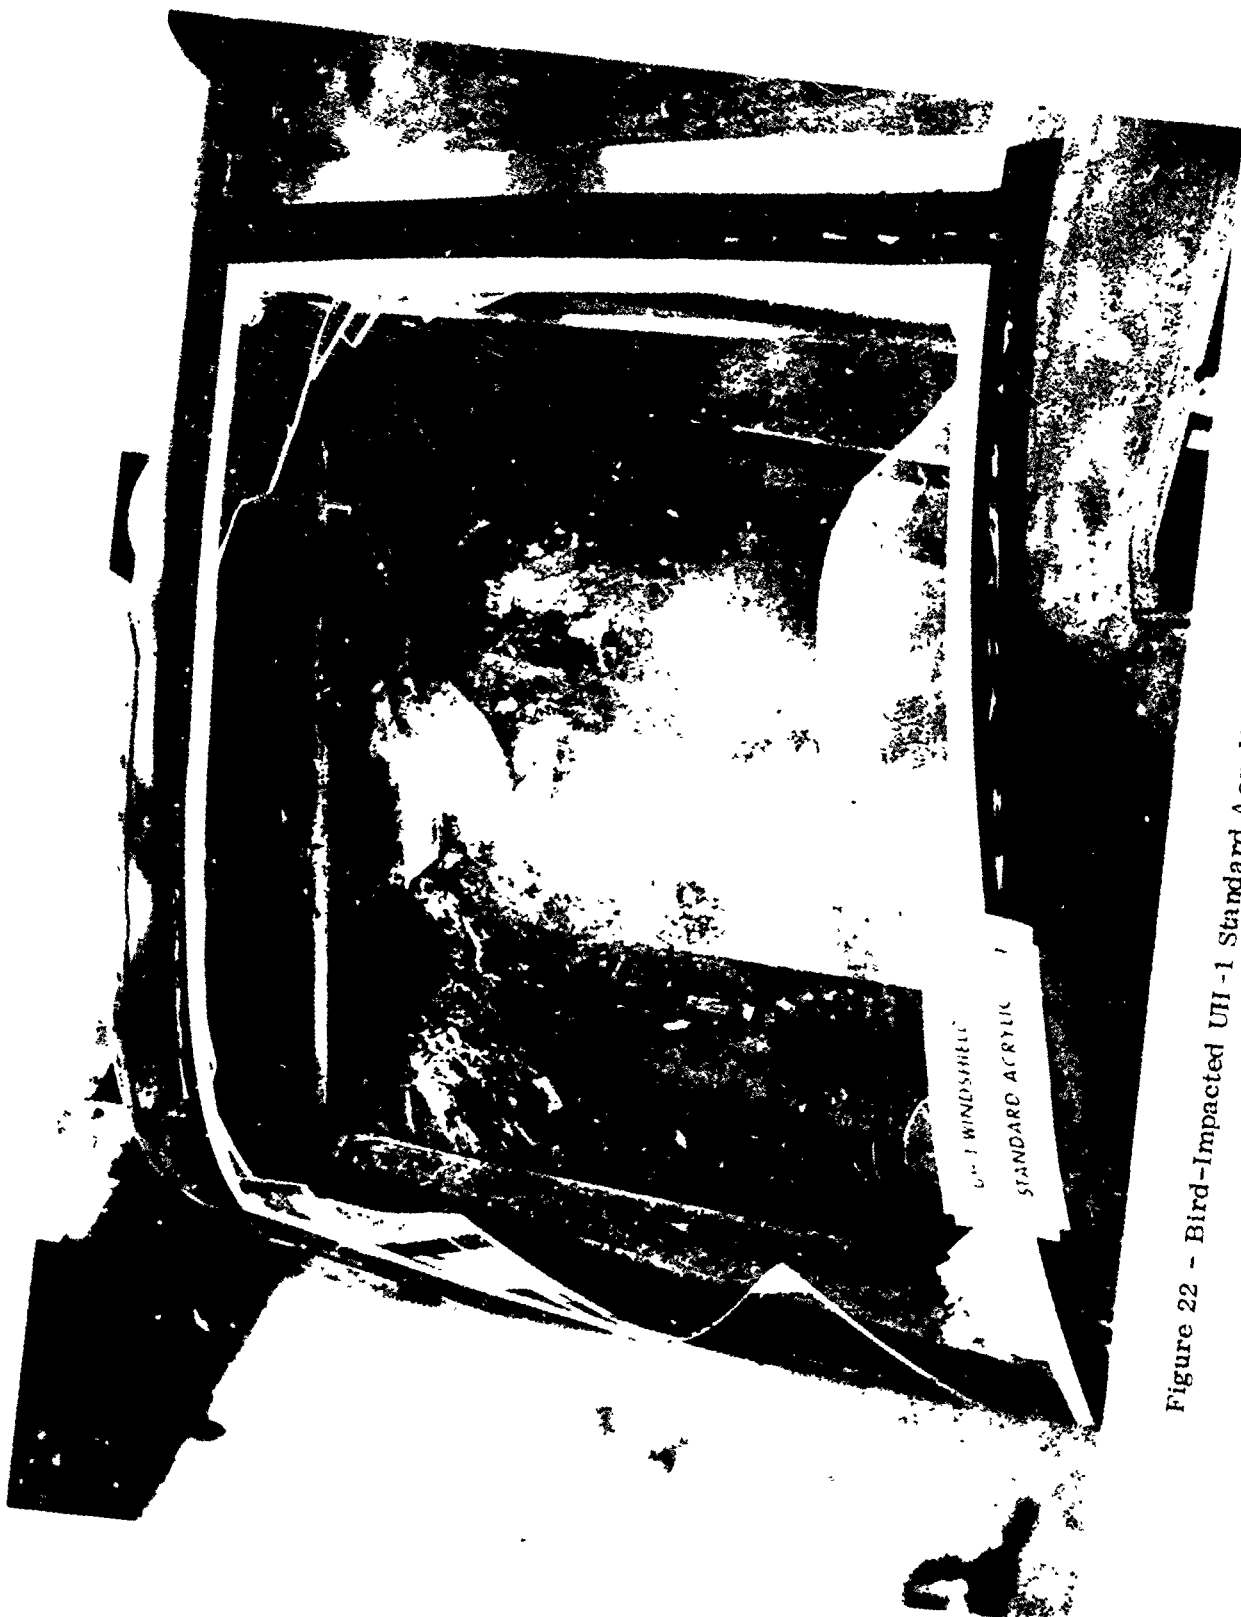
Standard acrylic windshield no. 1 was then mounted in the fuselage and was impacted with the four-pound bird traveling at 121.9 knots. The bird penetrated the windshield and hit the back of the vacuum chamber. The Plexiglas

broke out of the frame with only a few jagged fragments remaining along the edge (see Figure 22).

Figure 22 - Bird-Impacted UH-1 Standard Acrylic Windshield Number 1

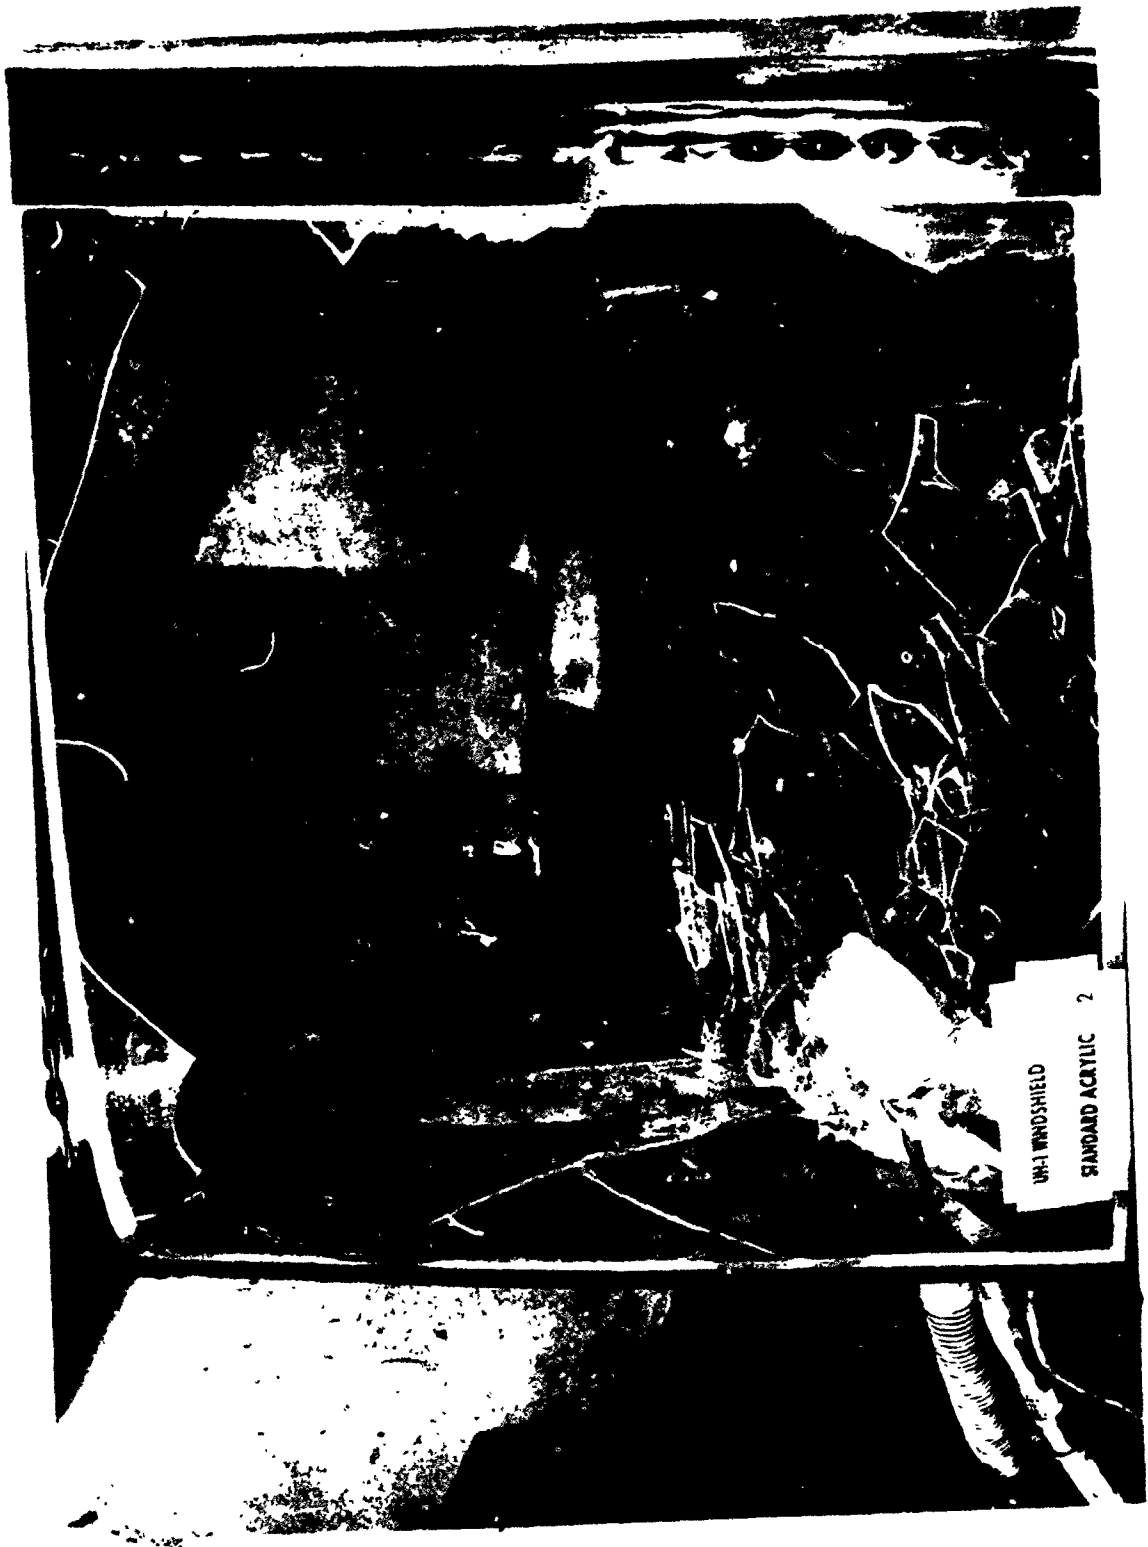
Because of the catastrophic failure mode of the first standard acrylic windshield, the second standard part was fired at 85.6 knots, which is nearer the cruising speed of the UH-1 aircraft. The bird also penetrated this windshield, breaking out nearly 80 percent of the acrylic (see Figure 23).

Figure 23 - Bird-Impacted UHI-1 Standard Acrylic Windshield Number 2
